# Conservation work at Petra: What had been done and what is needed

<sup>a</sup>Fadi Bala'awi\*, <sup>a</sup> Mohammed Waheeb <sup>a</sup>, Yahya Alshwabkeh, and <sup>a</sup> Firas Alawneh

<sup>a</sup>Queen Rania's Institute of Tourism and Heritage  
Hashemite University  
Zarqa-Jordan  
P.O. Box 150459, Zarqa 13115, Jordan

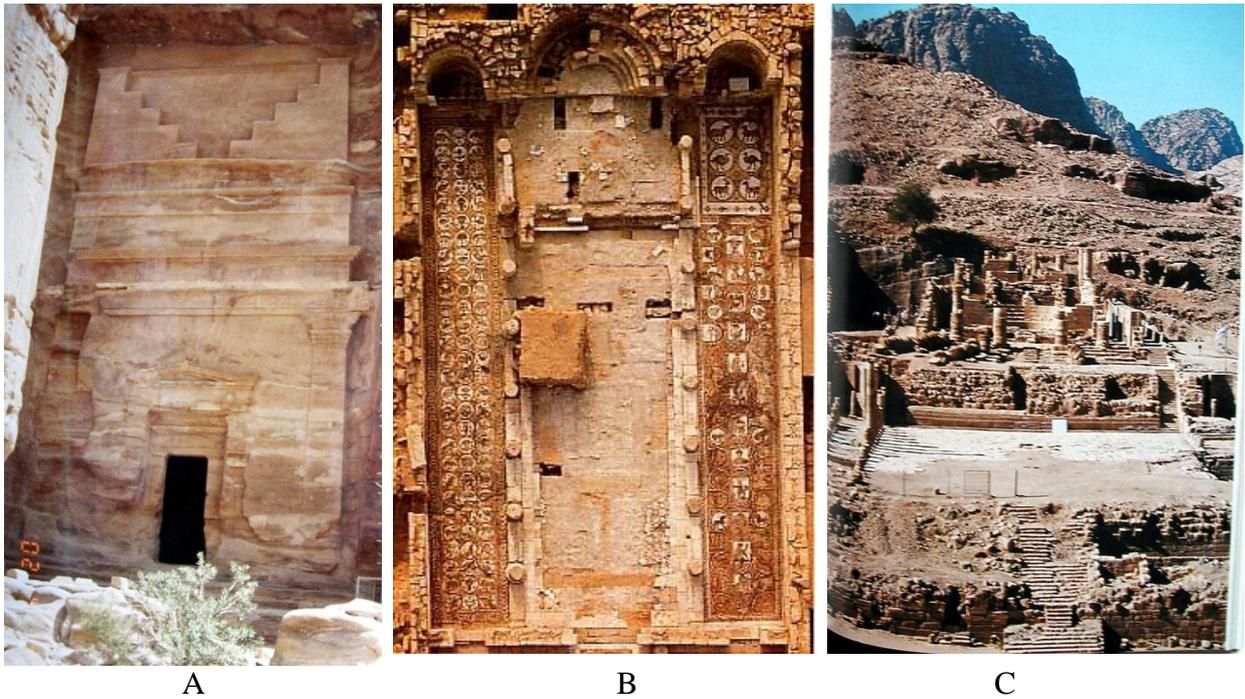
Figure (2) The three case study monuments

A: Tomb 825, B: Byzantine Church, Source: ACOR (2000) and C: The Great Temple, Source: Taylor (2001)

Tomb 825 (Figure 2, A) according to Brunnow's classification and sometimes it is known as The Tomb of the 17 Graves, since it has fourteen graves cut into its floor and three more in large rectangular recess in the back wall (Khouri 1986). Shaer and Aslan 2000 reported that this tomb is consisted of two sets of large steps, a cavetto cornice, an attic storey and a classical cornice. The importance of this tomb can be summarized in its typical Nabateans architecture style, representatively to the Nabateans family tomb and in the conservation work that took place in this tomb.

Brown University (1993-2000) excavated the Great Temple (Figure 2, C) under the direction of Martha harp Joukowsky. The temple is about 105 feet (35 m) east-west and 127.5 feet (42.5 m) length, and composed mainly of monumental entryway or what it is called “Propylaeum”, Lower Temenos, East and West Exedra which lead to the Upper Temenos-the scared enclosure for the temple proper (Joukowsky 1999). The temple was constructed for he Nabateans god Al Uzza. The floor frieze element that had been founded during Brown University excavation in the temple suggested that the temple was constructed in the last quarter of the first century BCE and a huge enlargement took place on the temple the first century CE. Bourbon 1999 reported that the temple was collapsed after an earthquake around the 6<sup>th</sup> century.

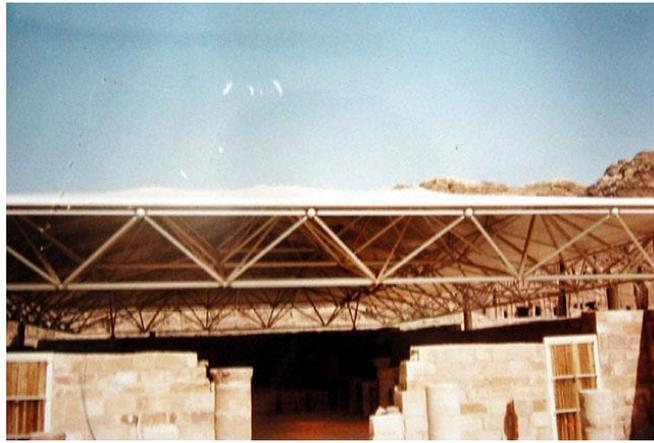
**- The constructing of the primary shelter:** - The most significant and complicated conservation approach in this project was the construction of a proper and primary shelter on the site. From the planning stage of the project, it has been noted the uncovering of the church mosaic will imply a construction of primary shelter to prevent these sensitive and unique pieces of art from the deterioration as result of reaction with water and sun. However, the shelter impact on the site context, cost, reversibility, minimum intervention, simplicity in installation, natural lighting & ventilation, flexibility & expandability, security and Environmental control were all a crucial approaches the shelter design should considered (Fiema, Kanelleopoulos, Waliszewski, & Schick 2001). Consequently, and due to the site exclusiveness, which required a shelter to cover the whole site with a minimum impact, there were two choices: building with massive foundation, or a modern but expensive technology, which known as space frame (Fiema, Kanelleopoulos, Waliszewski, & Schick 2001, and ACOR 2000). The project committee was completely aware of the site sensitivity and exclusivity, so the space frame technology was chosen. The shelter rides on only on six columns completely reversible ones. Moreover, the canopy consists of an extruded aluminum with a vinyl covering (ACOR 2000). It is worthwhile to mention that the installation process take 5 weeks only. The author believes that shelter design was

really satisfactory in different aspects. Firstly, it's minimum intervention approach. . Secondly, its reversibility and flexibility, since it is a huge change to organelle context of the site. Burra charter, article 15.2, recommend that change reduce cultural significant should be reversible, and be reversed when circumstance permit. Moreover, the shelter design succeeded in providing acceptable natural ventilation and lighting schemes. In addition, since the shelter dose not produced a green house heat affect as it the case in some shelter design that used a plastic translucent. In other word the environment inside the shelter are more or less stable. Finally, the shelter does not affect the visitors enjoyment of the site, in contrast, it add an educational value of the site. For instance, it reflects the original size of the site, its importance and finally the conservation efforts that had been done to protect such an important cultural heritage site. On the other hand, there are some points the points in the shelter design project the author does not agree with. Firstly, the shelter is the only modern structure in the city, which is in my point of view add a new context to the site, which should be avoided as much as possible. In another word, the shelter design did not looks compatible with the surrounding environment. Stanley Price (1997) mentioned that the type of shelter solution on archaeological sites should be aesthetically compatible with the environment of the ancient remains. Beside that, the maintenance of such structure is quite expensive and required a foreign expertise, which may not be available in the future, since the project is completely carried out through a foreign foundations. Jerome (1995) reported the shelter construction on archaeological sites, especially in the developing countries, must be carried out in low cost and dose not required a higher maintenance budget.

In Short, it certainly true that the construction of Petra Church shelter was a crucial intervention to ensure a longer life for a wonderful property and to minimize the environmental impact on a unique and sensitive structure. The shelter design was generally aware of the international approaches in such intervention. Its reversibility, flexibility, safety to the site component and its control to internal environment were the main advantages. In contrast, from the author point of view, the shelter design did not fit with city context and it maintenance could be a future problem.

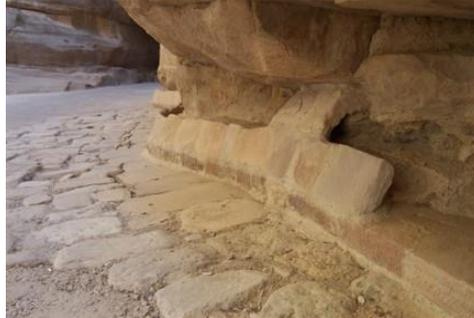
Figure 3: Ceramic pipes at The Siq (main entrance to Petra)

of the water erosion problem in their area; they constructed ceramic pipes along the bedrock and the face of the monuments to protect them from the running water (figure 3). Moreover, the horizontal surfaces were covered with multilayered mortar to minimise the effect of running water on these features (Shaer and Aslan 2000).

Unfortunately, nowadays, the Nabatean water system is the main cause of water erosion at the site. Joints and cracks that were created by earthquakes as well as the clogging of the Nabatean water channels allow the water to attack the Petra monuments from within and from outside (Fischer 2000).

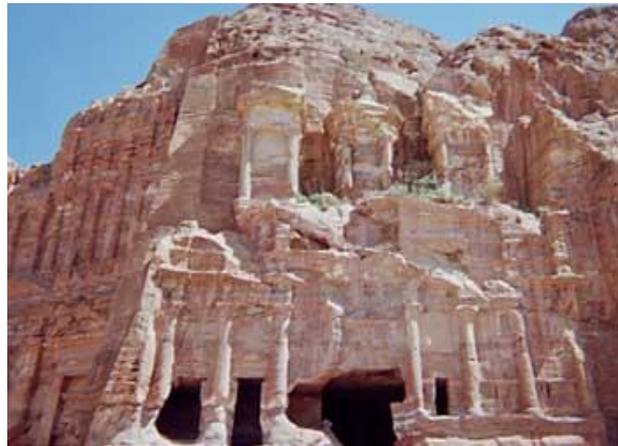
Figure4: The Corinthian Tomb, Petra, Jordan (August 2003)

The main biological weathering feature in Petra is the overgrowth of grass in and around the monuments. The availability of water allows vegetation to grow on some of the façades, such as the Corinthian Tomb (figure 4), causing considerable destruction of the façades' structure. Insect colonisation in certain monuments also enhances the damage by trapping the water under their nests and blocking its evaporation (Al Naddaf 2002). It should be stated that the impact, if any, of micro-organisms on stone decay in Petra, which could have a significant role in the biological weathering of the monuments, has not been studied.
